# Hickam Air Force Base Historic Housing District

A Guide For Hickam Communities' Residents

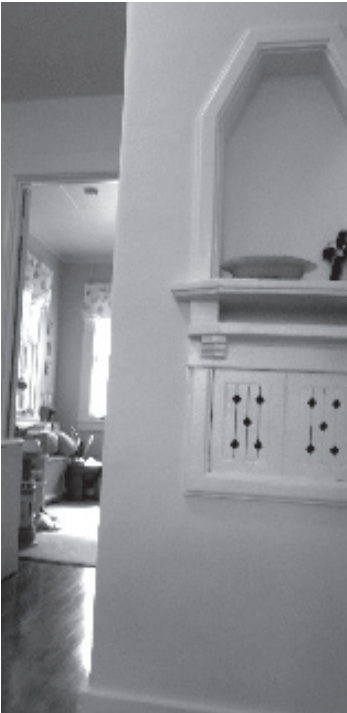
## Paint Finishes, Molding & Details

- Paint has to be renewed periodically. Repeated painting causes a thick buildup that can obscure building details. Painting of any kind should not be undertaken without prior approval by the Hickam Communities Maintenance Management office.

- Do not remove any historic wood moldings, trims, or other features. These are important elements that contribute to the visual character of our historic houses. Some houses have unique interior features that were designed-in when the house was originally constructed. These include telephone and ironing board recesses, corner cabinets, metal stair handrails, and wood wainscot paneling.

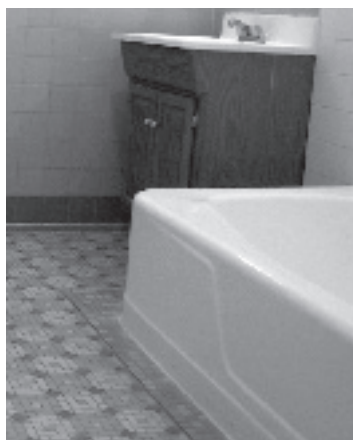
## Ceramic Tile

- The intricate ceramic tile patterns in the bathrooms of many of the historic houses are very unique to this housing type and construction period.
- Tiles should be cleaned with mild cleaning solutions and never an abrasive cleaner. Check the tile periodically for loose or missing grout. If any tiles become loose, please gently remove and safely store them until the Hickam Communities Maintenance Management staff can respond to your request for assistance.

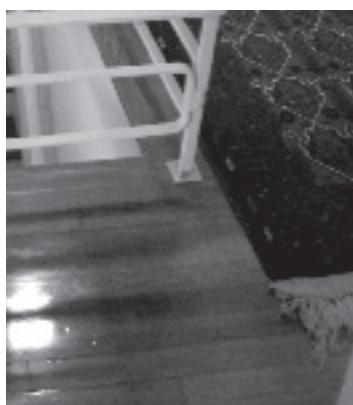
## Wood Floors

- Wood floors are made of tongue-and-groove pine boards.
- The only maintenance required for varnished wood floors is occasional cleaning with a slightly damp, cloth-pad-type mop or sponge. Water should be used very sparingly and immediately wiped dry.
- Floors should not be sanded and refinished, as this changes their appearance.

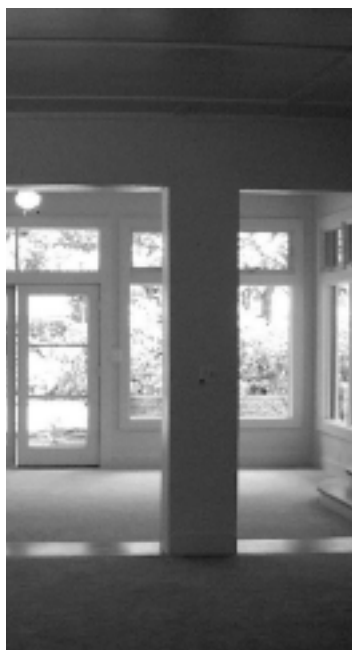
## Windows

- Keep glass clean. Dirt allowed to collect on the glass will cause it to become etched and difficult to see through.
- On the outside of the windows, if there is loose or missing putty at the edges of the glass, report this as soon as possible.

- If cracks or breaks in the exterior paint film or any signs of the wood swelling and splitting are observed, report this also. This includes gaps in the sealant joints between the window frame and the walls of the house.

- Sash cords should be checked every six months for signs or wear. If one of the sash cords fails it will make the window hard to operate. Failure of both cords could cause serious damage to the window or anyone trying to operate the window.

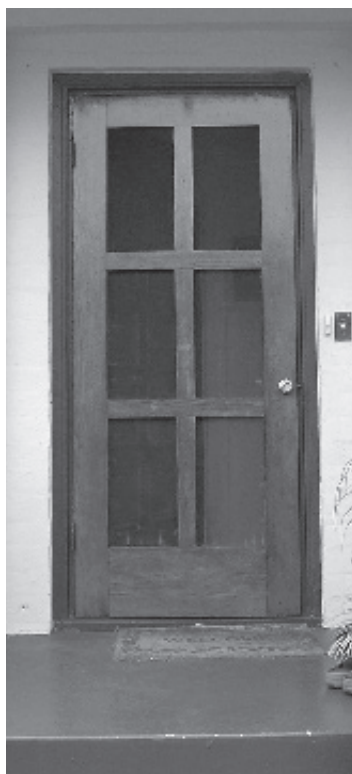
## Doors

- The distinctive decorative patterns on the doors of some of these homes are important historical elements.
- Similar maintenance procedures should be followed as for windows. Keep doors clean and the paint coatings maintained is important to the care of these elements. As painting in historic homes will be undertaken by Hickam Community Housing, report any deficiencies to the contact number listed at the end of this brochure.
- Do not add extra hardware such as deadbolts to the doors without prior approval from Hickam Community Housing. This not only changes the historic appearance but also damages the door. Existing hardware should be cleaned with appropriate materials and locks and hinges lubricated regularly.
- If a door begins to bind or jam against the frame it should never be forced. Report the problem to the Hickam Communities Maintenance Management office.

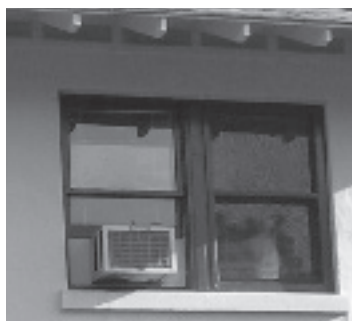
## Window Air Conditioners

- If a window air conditioner or conditioners have been installed, you should watch closely and often for any water leaking or any other problems that may cause damage to the home. Any problems should be immediately reported to the Hickam Communities Maintenance Management office to ensure further damage does not result.

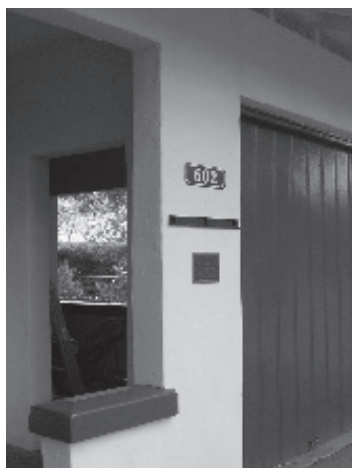
## Exterior Walls

- The exterior walls are made of concrete blocks. In the two-story historic homes the walls of the upper floors are sometimes wood frame with stucco finish.
- The masonry materials are durable and regular painting is all the maintenance that should be needed (and all painting will be undertaken by Hickam Community Housing.) Cracks may occur if there are root problems from trees or other vegetation. Significant damage can occur if water penetrates the interior of the wall. This can cause the steel reinforcing to corrode and expand. If residents notice any significant cracks they should report this as soon as possible.

The exterior walls are built of concrete blocks with concrete slab ground floors. In some of the two-story houses, the exterior walls are masonry on the first story and wood frame construction with plaster finish on the second story. Although masonry construction is unusual in Hawaiian houses as it is generally more expensive, it follows a tradition in military housing and has advantages over wood in durability and thermal performance.

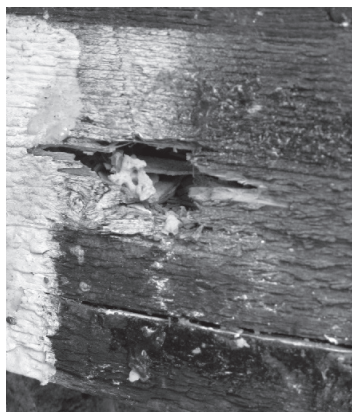
## Termite Damage to Wood

- Termite infestation of wood is a major problem in Hawaii.
- At the time these houses were built, wood was not treated with preservative, as it is today, nor was the termite problem as severe. Hawaii is burdened with two different types of voracious termites: ground (subterranean) and flying (dry wood) termites. Both types can cause tremendous damage to wood and other materials. Periodic tenting of the houses is sometimes needed to treat the home for termites.

- Termite damage can often be hard to spot because termites can be eating away inside the wood while the outside is undisturbed. Lightly tapping on wood elements can expose areas that have been hollowed by termites. Small piles of what resembles sawdust are also indications that termites may be at work. Residents should immediately report any signs of apparent termite damage in or around their home to the Hickam Communities Maintenance Management office.

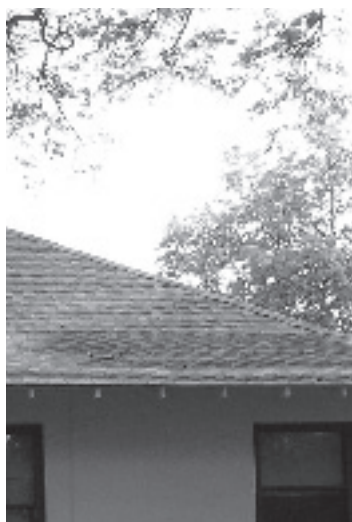
## Roofs

- The roof coverings are either clay tile or asphalt shingle.
- Leaves and other debris falling on the roof can build up in the gutters, eventually blocking the outlets and causing gutter overflow. This situation promotes rotting of wood elements at the eaves. Hickam CommunitiesMaintenance teams will conduct periodic inspections of roofs. However, should you notice any build up of debris, report it immediately to the Hickam CommunitiesMaintenance Management office. Additionally, any leaking or overflowing gutters and cracked or dislodged roofing materials should be reported as soon as observed.

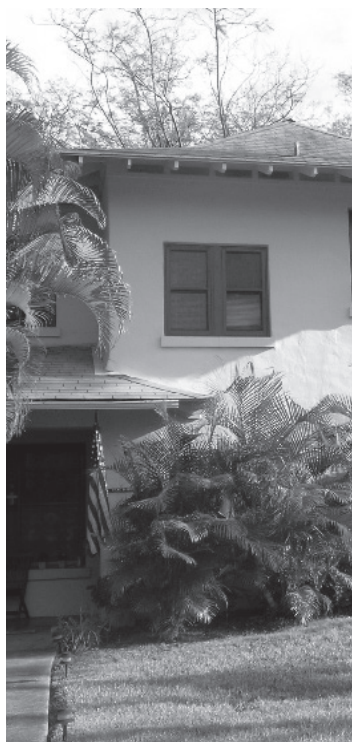
## Landscaping

- The trees and lush tropical landscaping at Hickam are among the most attractive features of the base. They contribute to what is now considered the Cultural Landscape of Hickam Historic Housing District.

- Shrubs against the side of the house should not be allowed to become overgrown as dense vegetation in contact with the materials at the base of the house can trap moisture. This can lead to decay and also provide a route for insects to enter the building.
